HM Railway Inspectorate

**RAILWAY ACCIDENT AT STAFFORD**

A report on a collision that occurred  
on 4 August 1990

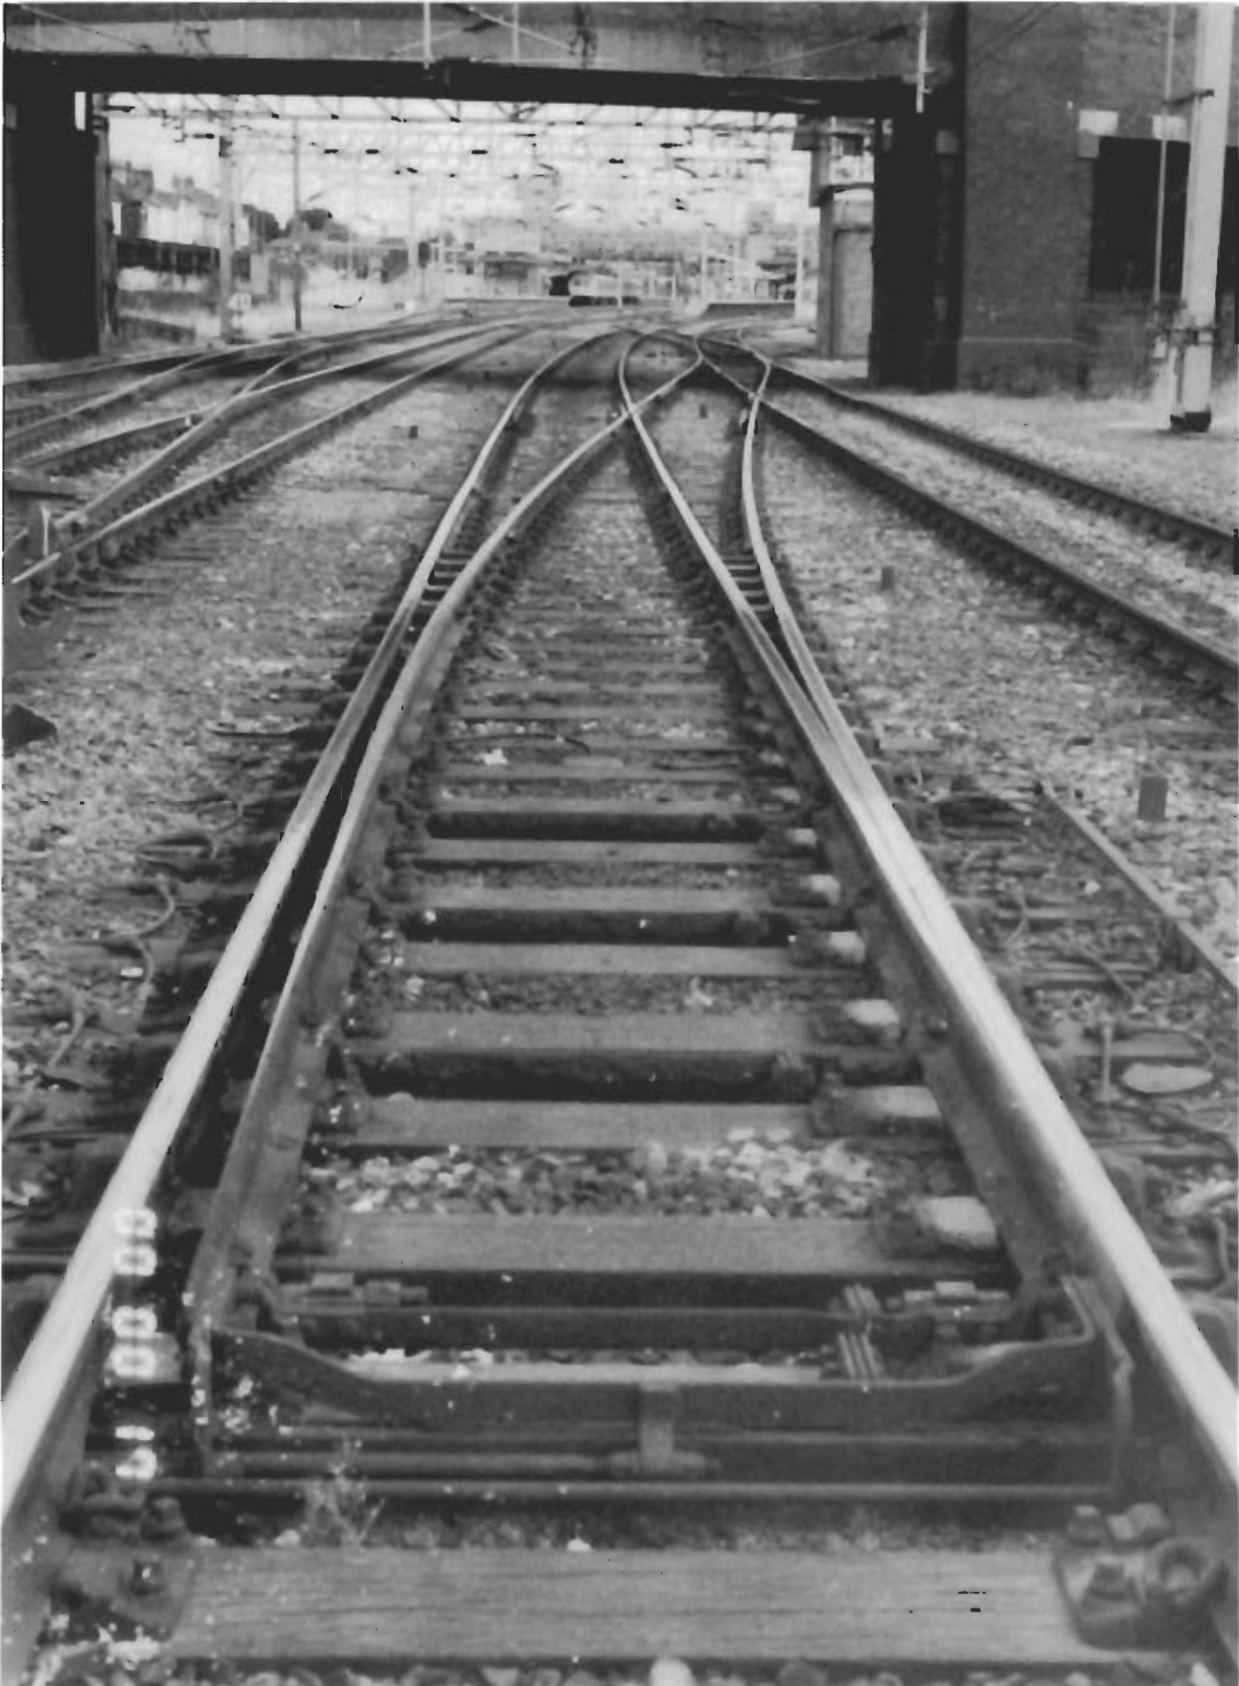
**Figure 4** View from Up Slow line of Bridge No 86, Stafford 5 Signal box and Stafford Station

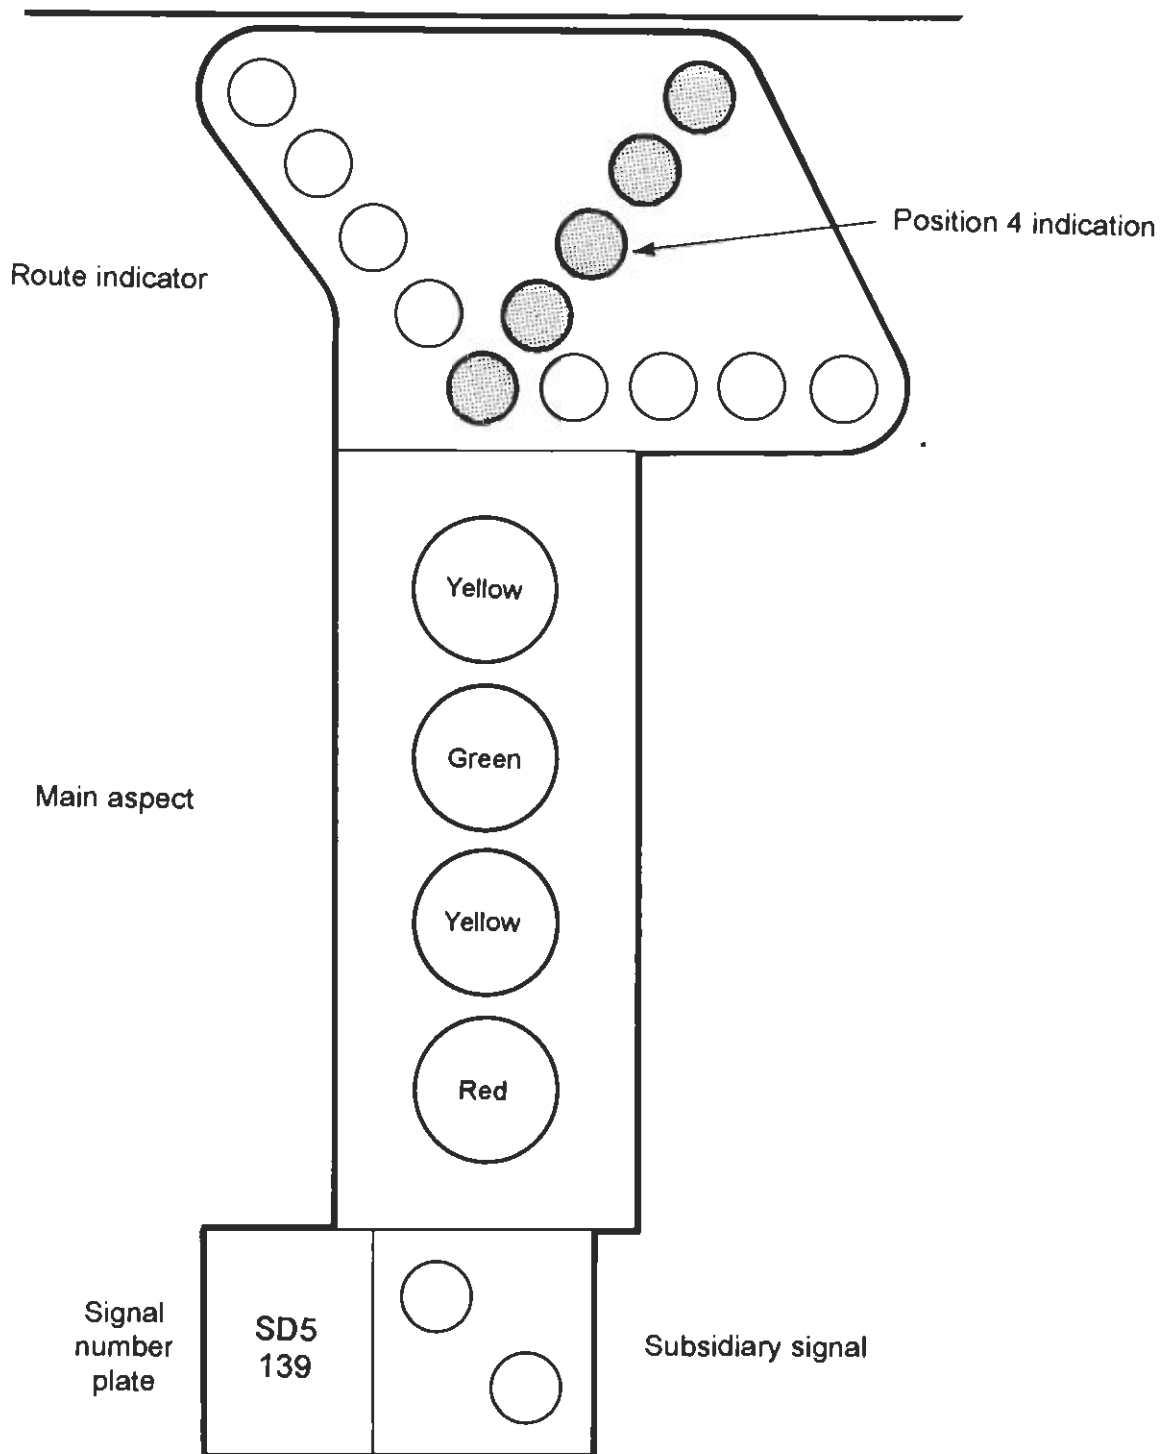
**Figure 2** Layout of Stafford SB139 signal

14 For a train to enter an *occupied* Platform 4, signal 139 would show the same route indicator, but would show a subsidiary proceed aspect comprising two white lights 250 mm apart on an inclined axis, while the main signal aspect remains red.

107 Although, as referred to later, Driver Sutton was probably less than *fully vigilant*, the visual signals he was presented with were not beyond criticism and I shall refer to them again in my recommendations. Firstly, at signal SD5 139 the brilliance of the five-light route indicator tended to over-power the subsidiary signal lights, although it must not be forgotten that the red main aspect remained on display. Secondly, since 1V27 had already been signalled to depart as 5G15 approached, Driver Sutton would have seen the green light of signal SD4 40 reflected along the side of the stationary train, although its flashing red tail lamp was nearer to him.

123 I *recommend* that the intensity of signal aspects showing together should be uniform so far as is reasonably practicable. While a route indicator may need to be high intensity if it is to be seen at a distance, where the same route indicator is to be shown in association with a subsidiary signal, the significance of the signal governing the limited extent of the movement should not be overpowered by the route indication showing its direction.

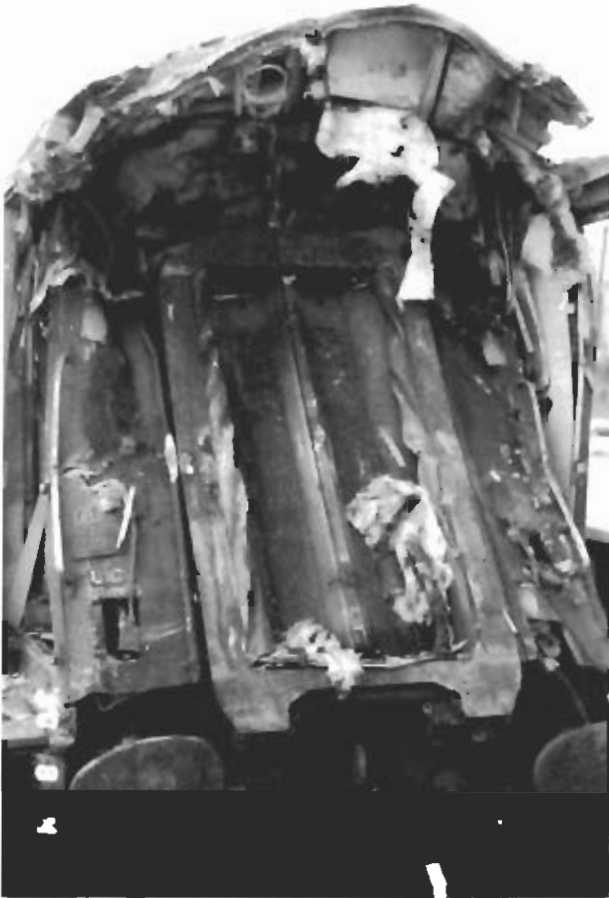
**Figure 3** Rear vehicle of 1V27. Coach No 17134.

Coach 17134 corridor brake first - there was considerable damage to this coach especially at the rear where the floor had buckled and the body sides rippled. The couplings at both ends were damaged, the trailing body end had been pushed inwards at the top breaking the connections between the body end structure and the roof. The roof skin had been torn away from the cantrails (see Figure 3).

81 Mr Hodgson postulated that the method of damage to the rear coach of 1V27 was that the underframe of the front car of the empty stock train had buckled under the force of the impact, which had forced the top of the cab of the EMU forward. This had damaged the vestibule plate of the rear coach of 1V27, causing the cantrail to fail resulting in the form of damage shown in Figure 3.
